Service Bulletin

Affected Models: LZA 2027 Tone Termination Panel

BKSB-1018

Date 7-7-03

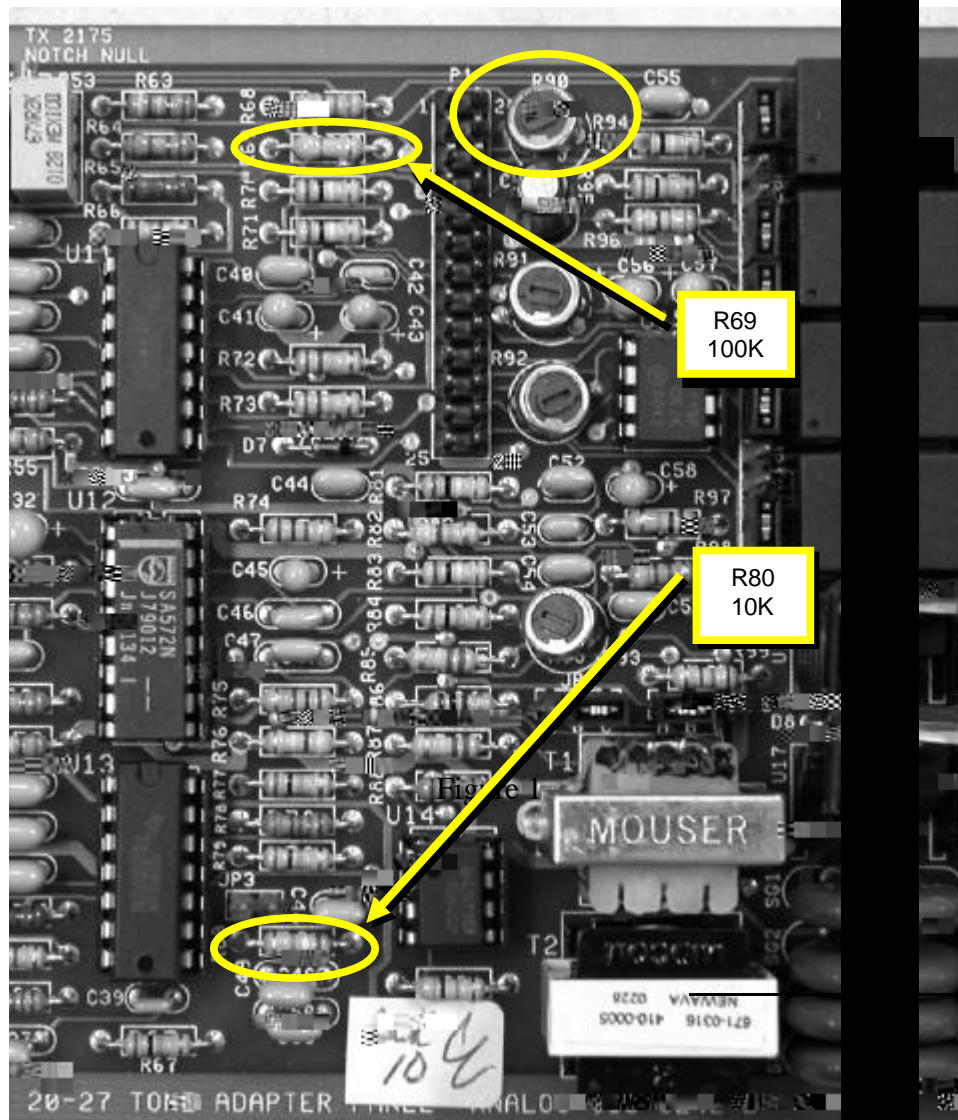
Figure 1 – Parts Placement

Issue: Difficulty adjusting “Line to TX Audio Level” and “RX Audio to Line Level”.

- a. Replace R69 with 100K (RELM p/n 4704-00104-032)
 - b. Replace R80 with 10K (RELM p/n 4704-00103-032)
3. If Technical Service Bulletin #1014 has not been implemented, it is recommended to do so now. Skip step 4.

4. If Technical Service Bulletin #1014 has been implemented, then do the follow adjustments (See Figure 1 for parts placement):
 - a. RX Audio to Line Level - While injecting a standard input signal from your RF generator (-60dBm RF, 3kHz wideband mode or 1.5 kHz narrowband mode deviation of 1kHz tone), adjust R92 until 0.24Vrms (-10dBm) is measured on the remote line.

- b. Line to TX Audio Level - While transmitting and modulating into the remote handset, adjust R90 until the deviation starts to limit just above 4kHz. Do not exceed 5kHz.
