Service Bulletin

BKSB-1011
Issue Date 11-19-01

Issue: Limited access to base station power supply fuse.

Affected Models: All GBH and GBV Base Stations received prior to November 19, 2001.

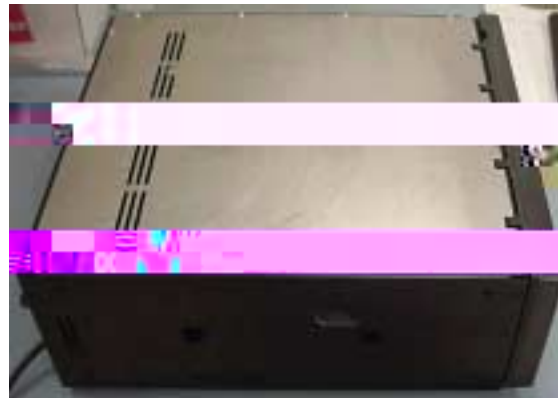
1. Remove the 8 cover screws from GBH/GBV chassis. Set aside wrap and screws. (Fig. 1)
2. Remove the 16 screws holding the chassis shield. Set aside screws and shield. (Fig. 2)
